An Analysis of Nondestructive Evaluation Techniques for Polymer Matrix Composite Sandwich Materials

9. SPONSORING/MONITORING AGENCY NAME(S) AND ADDRESS(ES) National Aeronautics and Space Administration Washington, DC 20546-0001			10. SPONSORING/MONITORING AGENCY REPORT NUMBER NASA TM-2006-214349

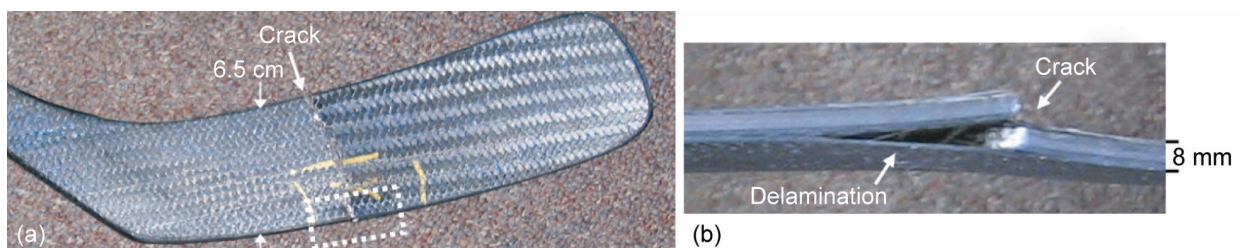
Figure 2.—Photographs of the hockey blade with a crack through the thickness of the foam and one of the face sheets: (a) an overall image of the hockey blade illustrating the location of the crack and (b) a side view from the bottom of the blade depicting the morphology of damage near the crack.

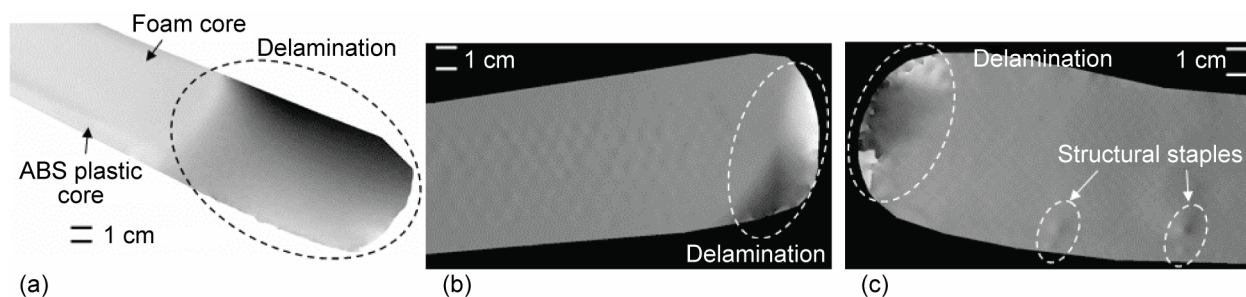
Figure 11.—Shearography images from the hockey blade with a delamination over half the blade (a), the hockey blade with an ABS plastic honeycomb core and a delamination at the tip (b), and a hockey blade containing structural staples and a delamination at the tip (c).

Shearography also detected delaminations in the face sheet or between the face sheet and the foam core. Figure 11 illustrates shearography images from three blades with delaminations. Typically defects, or structurally weaker regions, are indicated with a “butterfly” pattern having alternating contrast levels over the defective region. The patterns shown in figure 11(b) and (c) over delaminated areas are most reflective of this type of damage indication. The damage in the blade depicted in figure 11(a) was extremely severe and easily detected with shearography. Although no images are presented here, shearography was also capable of detecting delaminations on the side opposite of, or furthest from, interrogation.

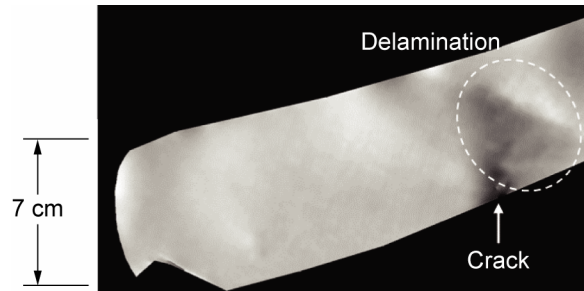
Figure 13.—Shearography results from a hockey blade with a crack through one of the face sheets and into the foam core. The crack and the delamination were detected and shown in the image.

Figure 13 depicts the shearography results from the blade with a crack through one of the face sheets and into the foam core. These results were acquired from the side of the hockey blade where the crack was not optically visible. The crack and the delamination were detected together in this image. The crack in the core of the hockey blade with the large delamination was not detected with shearography due to the response of the crack being masked by the response of the delamination.
